Replacement RS3 Media Flash Drives

Flash Tape Board Part# CA-RTEK11 Flash Disk Board Part# CA-RTFDB11

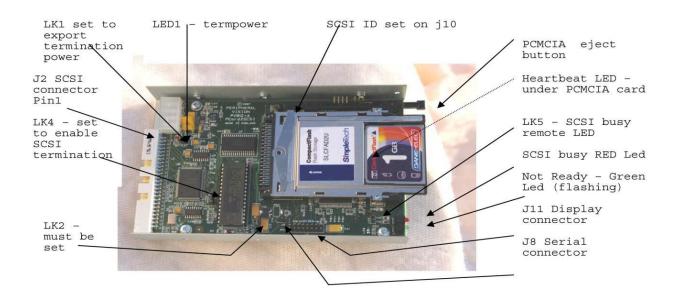
With legacy computer systems such as Rosemount RS3, problems can often arise when replacing old or worn out tape and disk drives. Replacing and repairing old SCSI disk and SCSI QIC drives can be problematic. The CA-RTFDB11 Flash Disk Board and CA-RTFTB11 Flash Tape Board can solve these issues. It replaces the moving parts of a tape drive and disk drive with a low cost rugged flash card, while emulating the legacy disk or QIC drive to the host on its SCSI bus.

The Rosemount RS3 SCSI controller has a single SCSI bus that is used to attach its disk (at ID5) and its tape drive (ID4) at the ends of the bus. The Rosemount controller itself sits in the middle of the bus. Both the tape and disk units should therefore be SCSI terminated. The disk unit is preformatted so that an initial restore is not required.
